COMPLETION REPORT

Remedial Action Construction

**Standard Steel And Metals Salvage Yard
Superfund Site
Anchorage Alaska**

AUGUST 1999

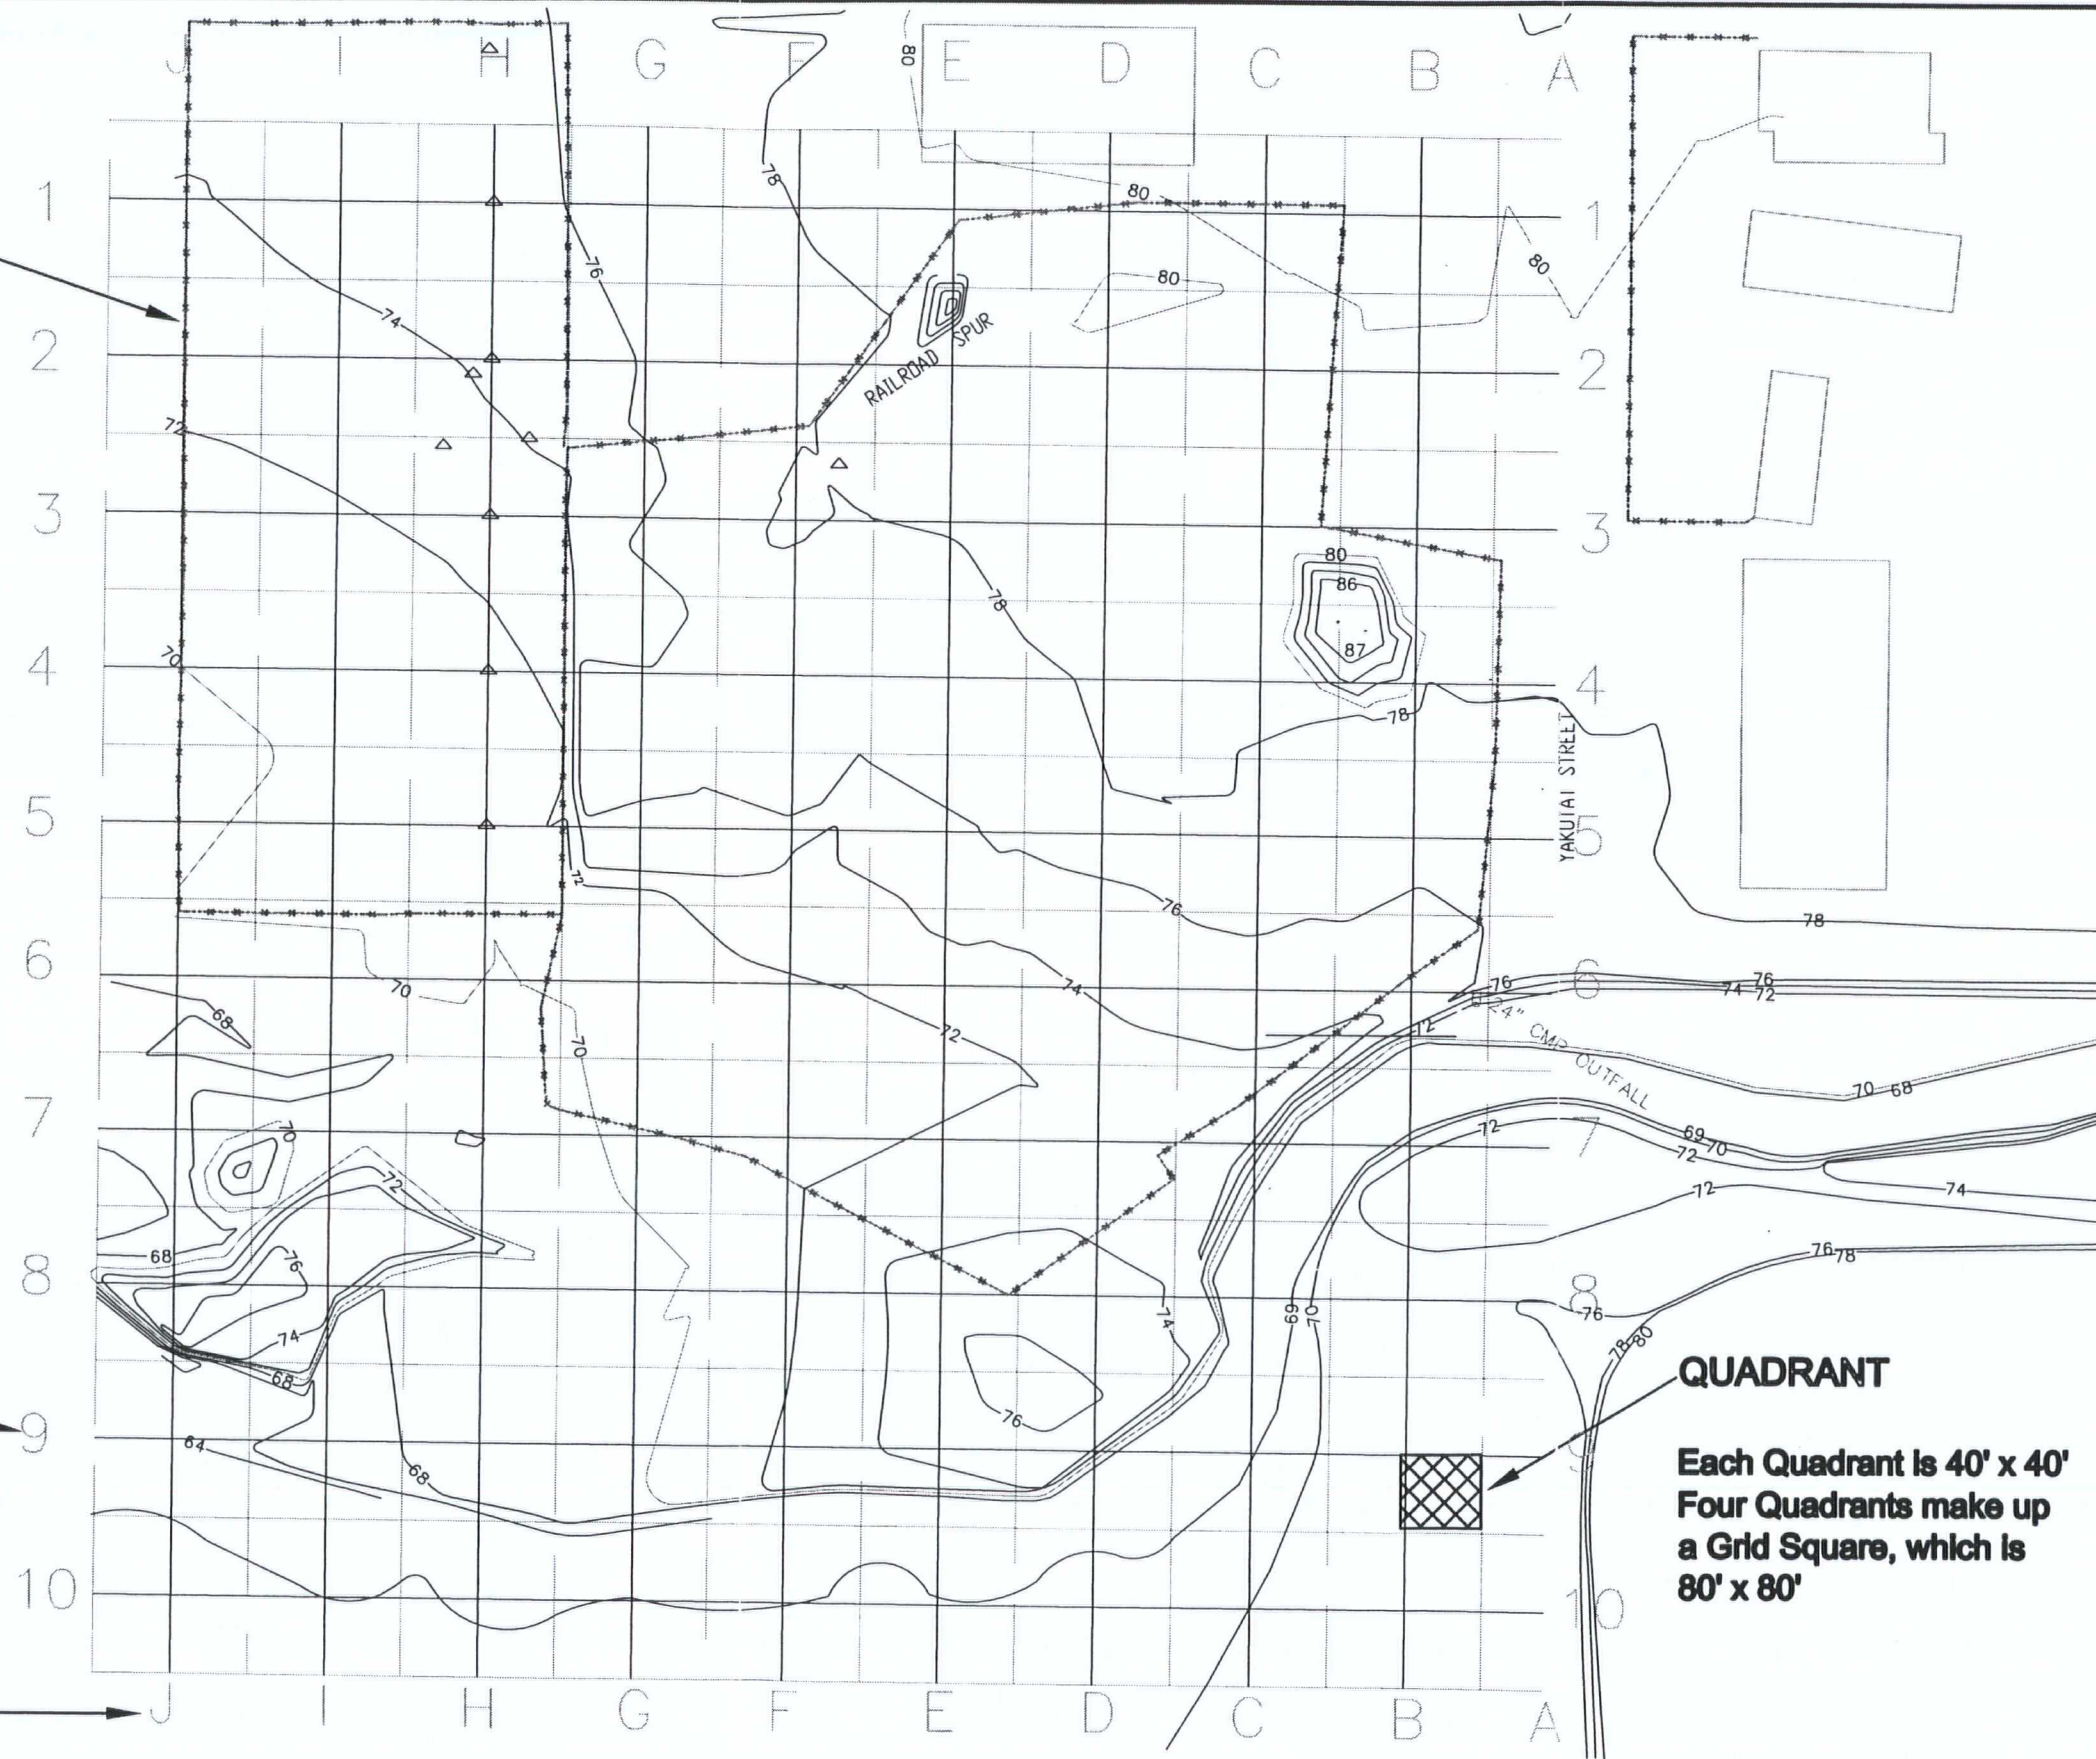
SITE GRID ROWS

SITE GRID COLUMNS

QUADRANT

Each Quadrant is 40' x 40'
Four Quadrants make up
a Grid Square, which is
80' x 80'

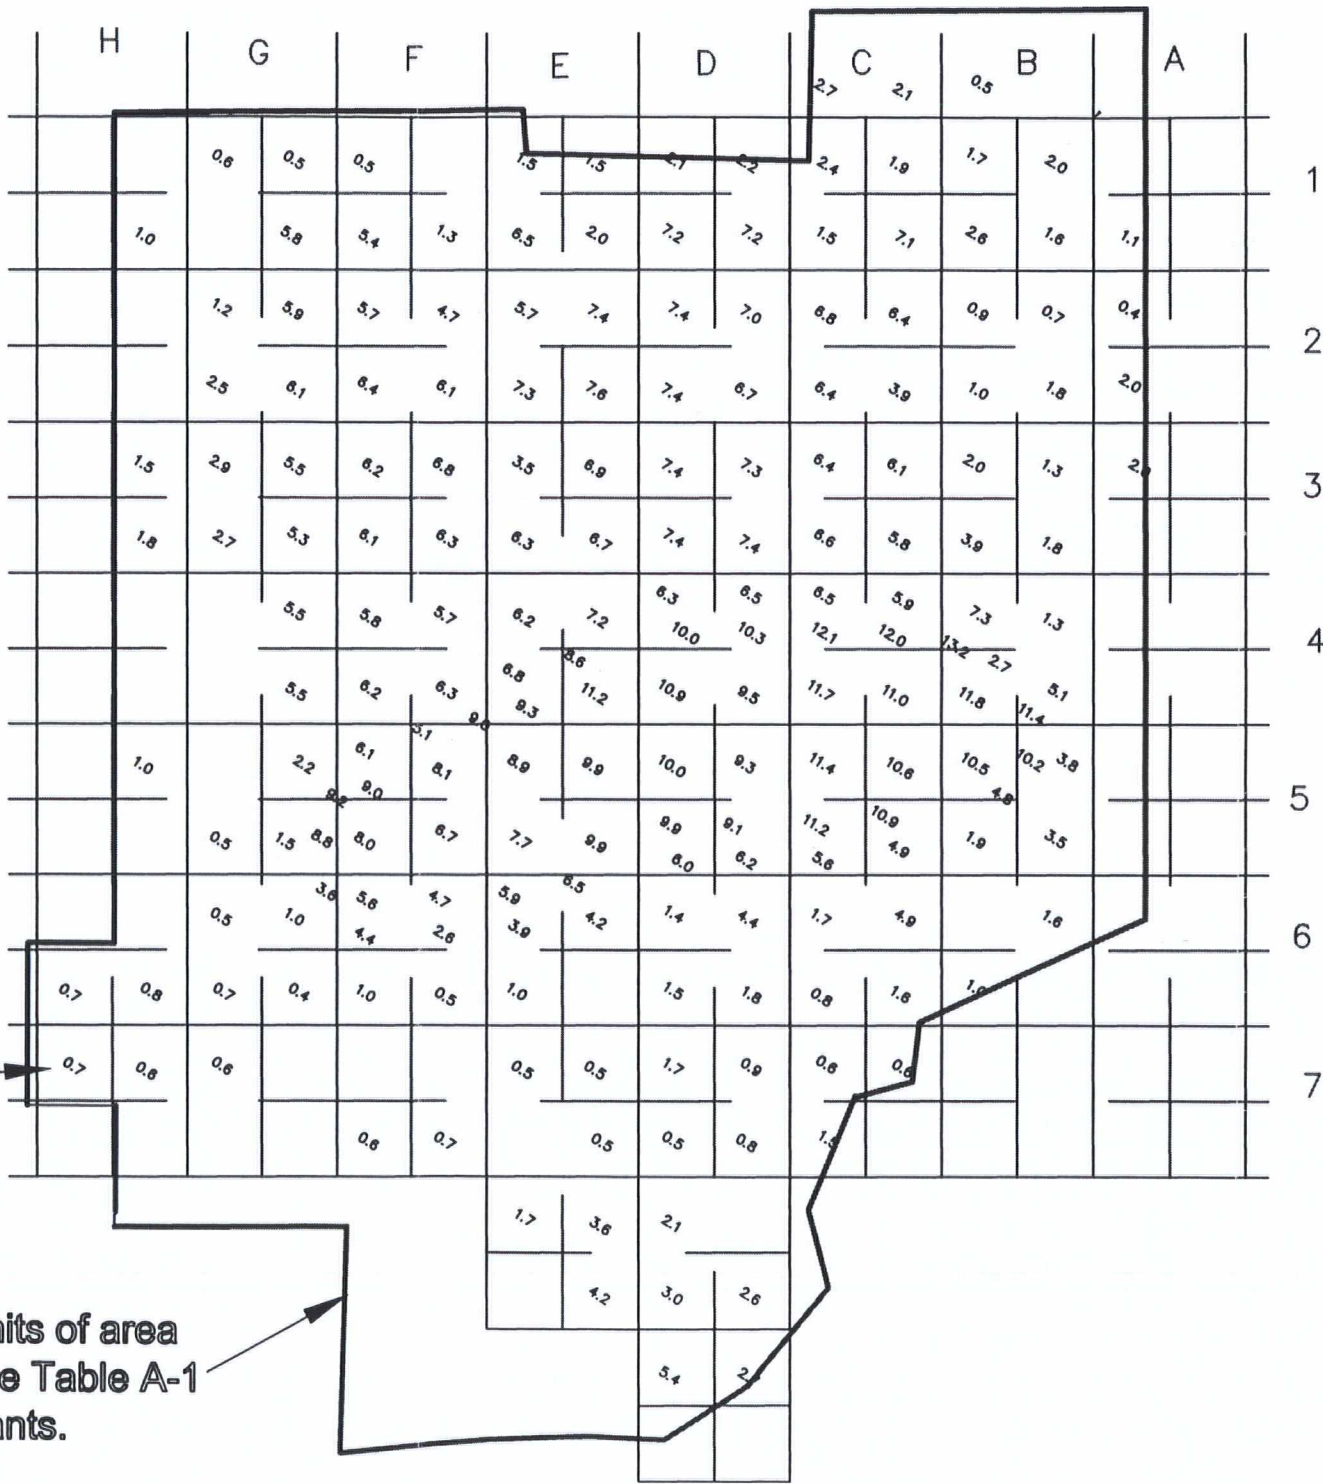
DEPTH OF EXCAVATION FROM ORIGINAL GROUND TO FINAL DEPTH (IN FEET)

Approximate limits of area remediated. See Table A-1 for list of quadrants.

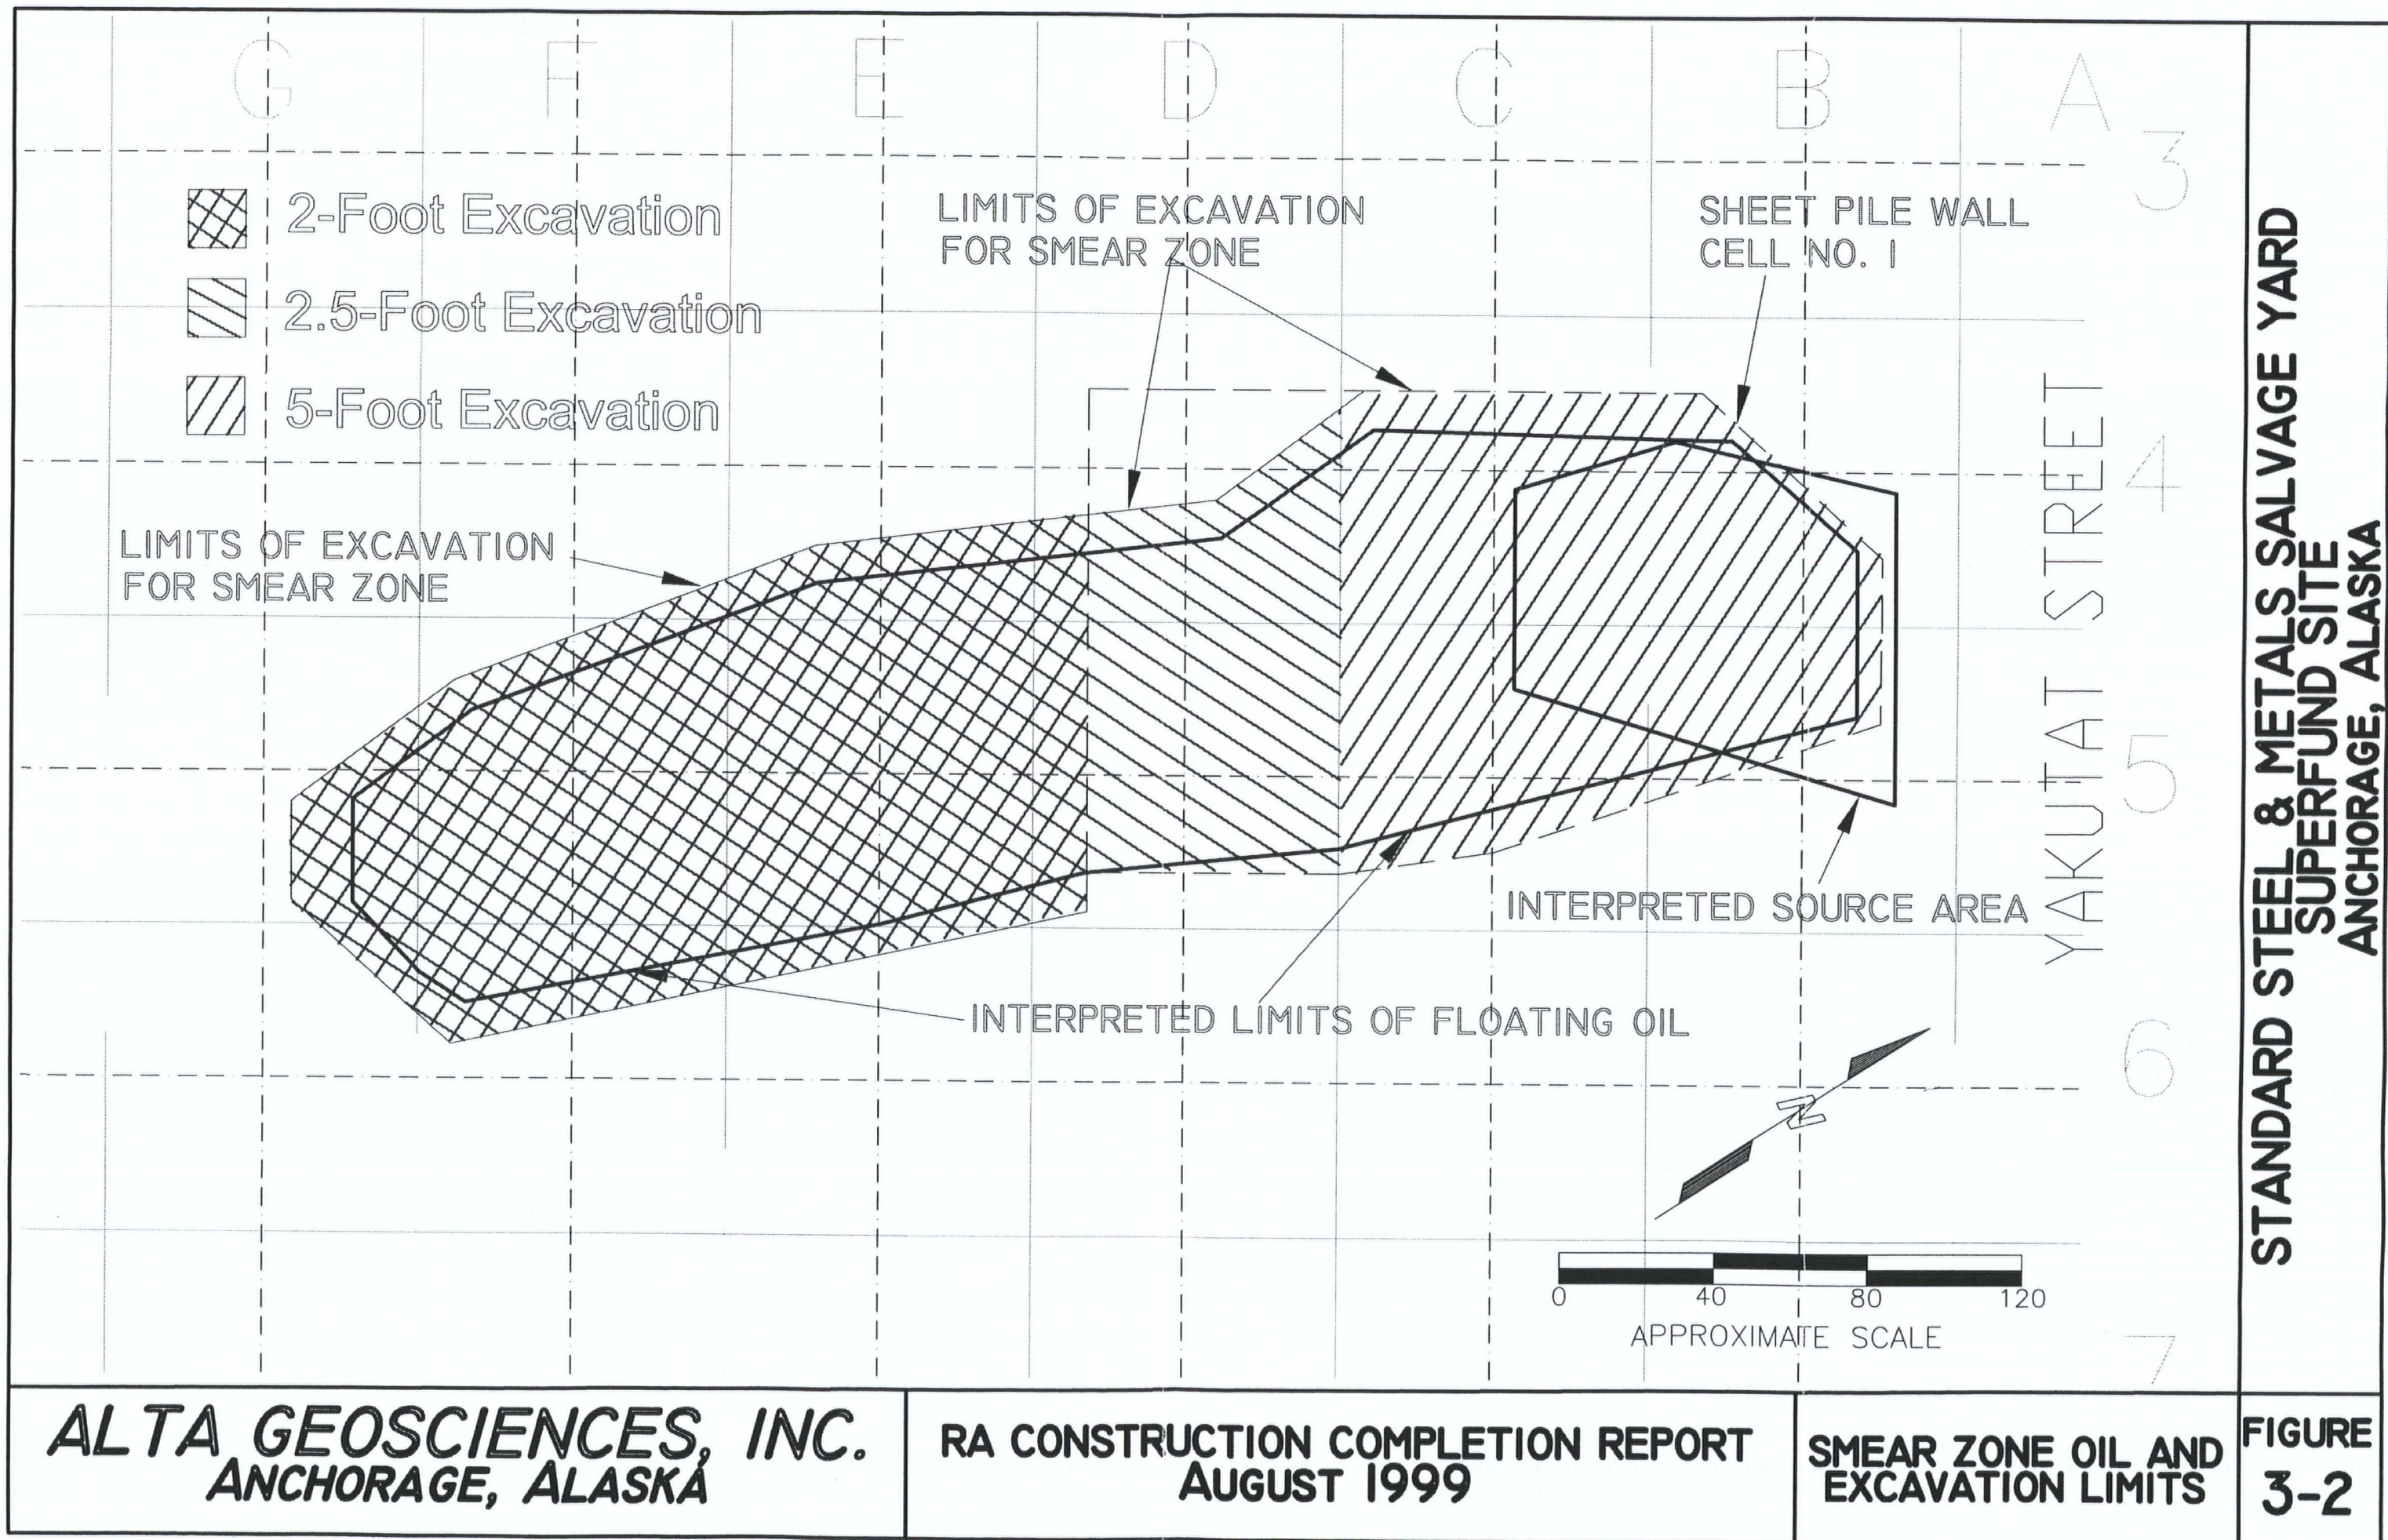
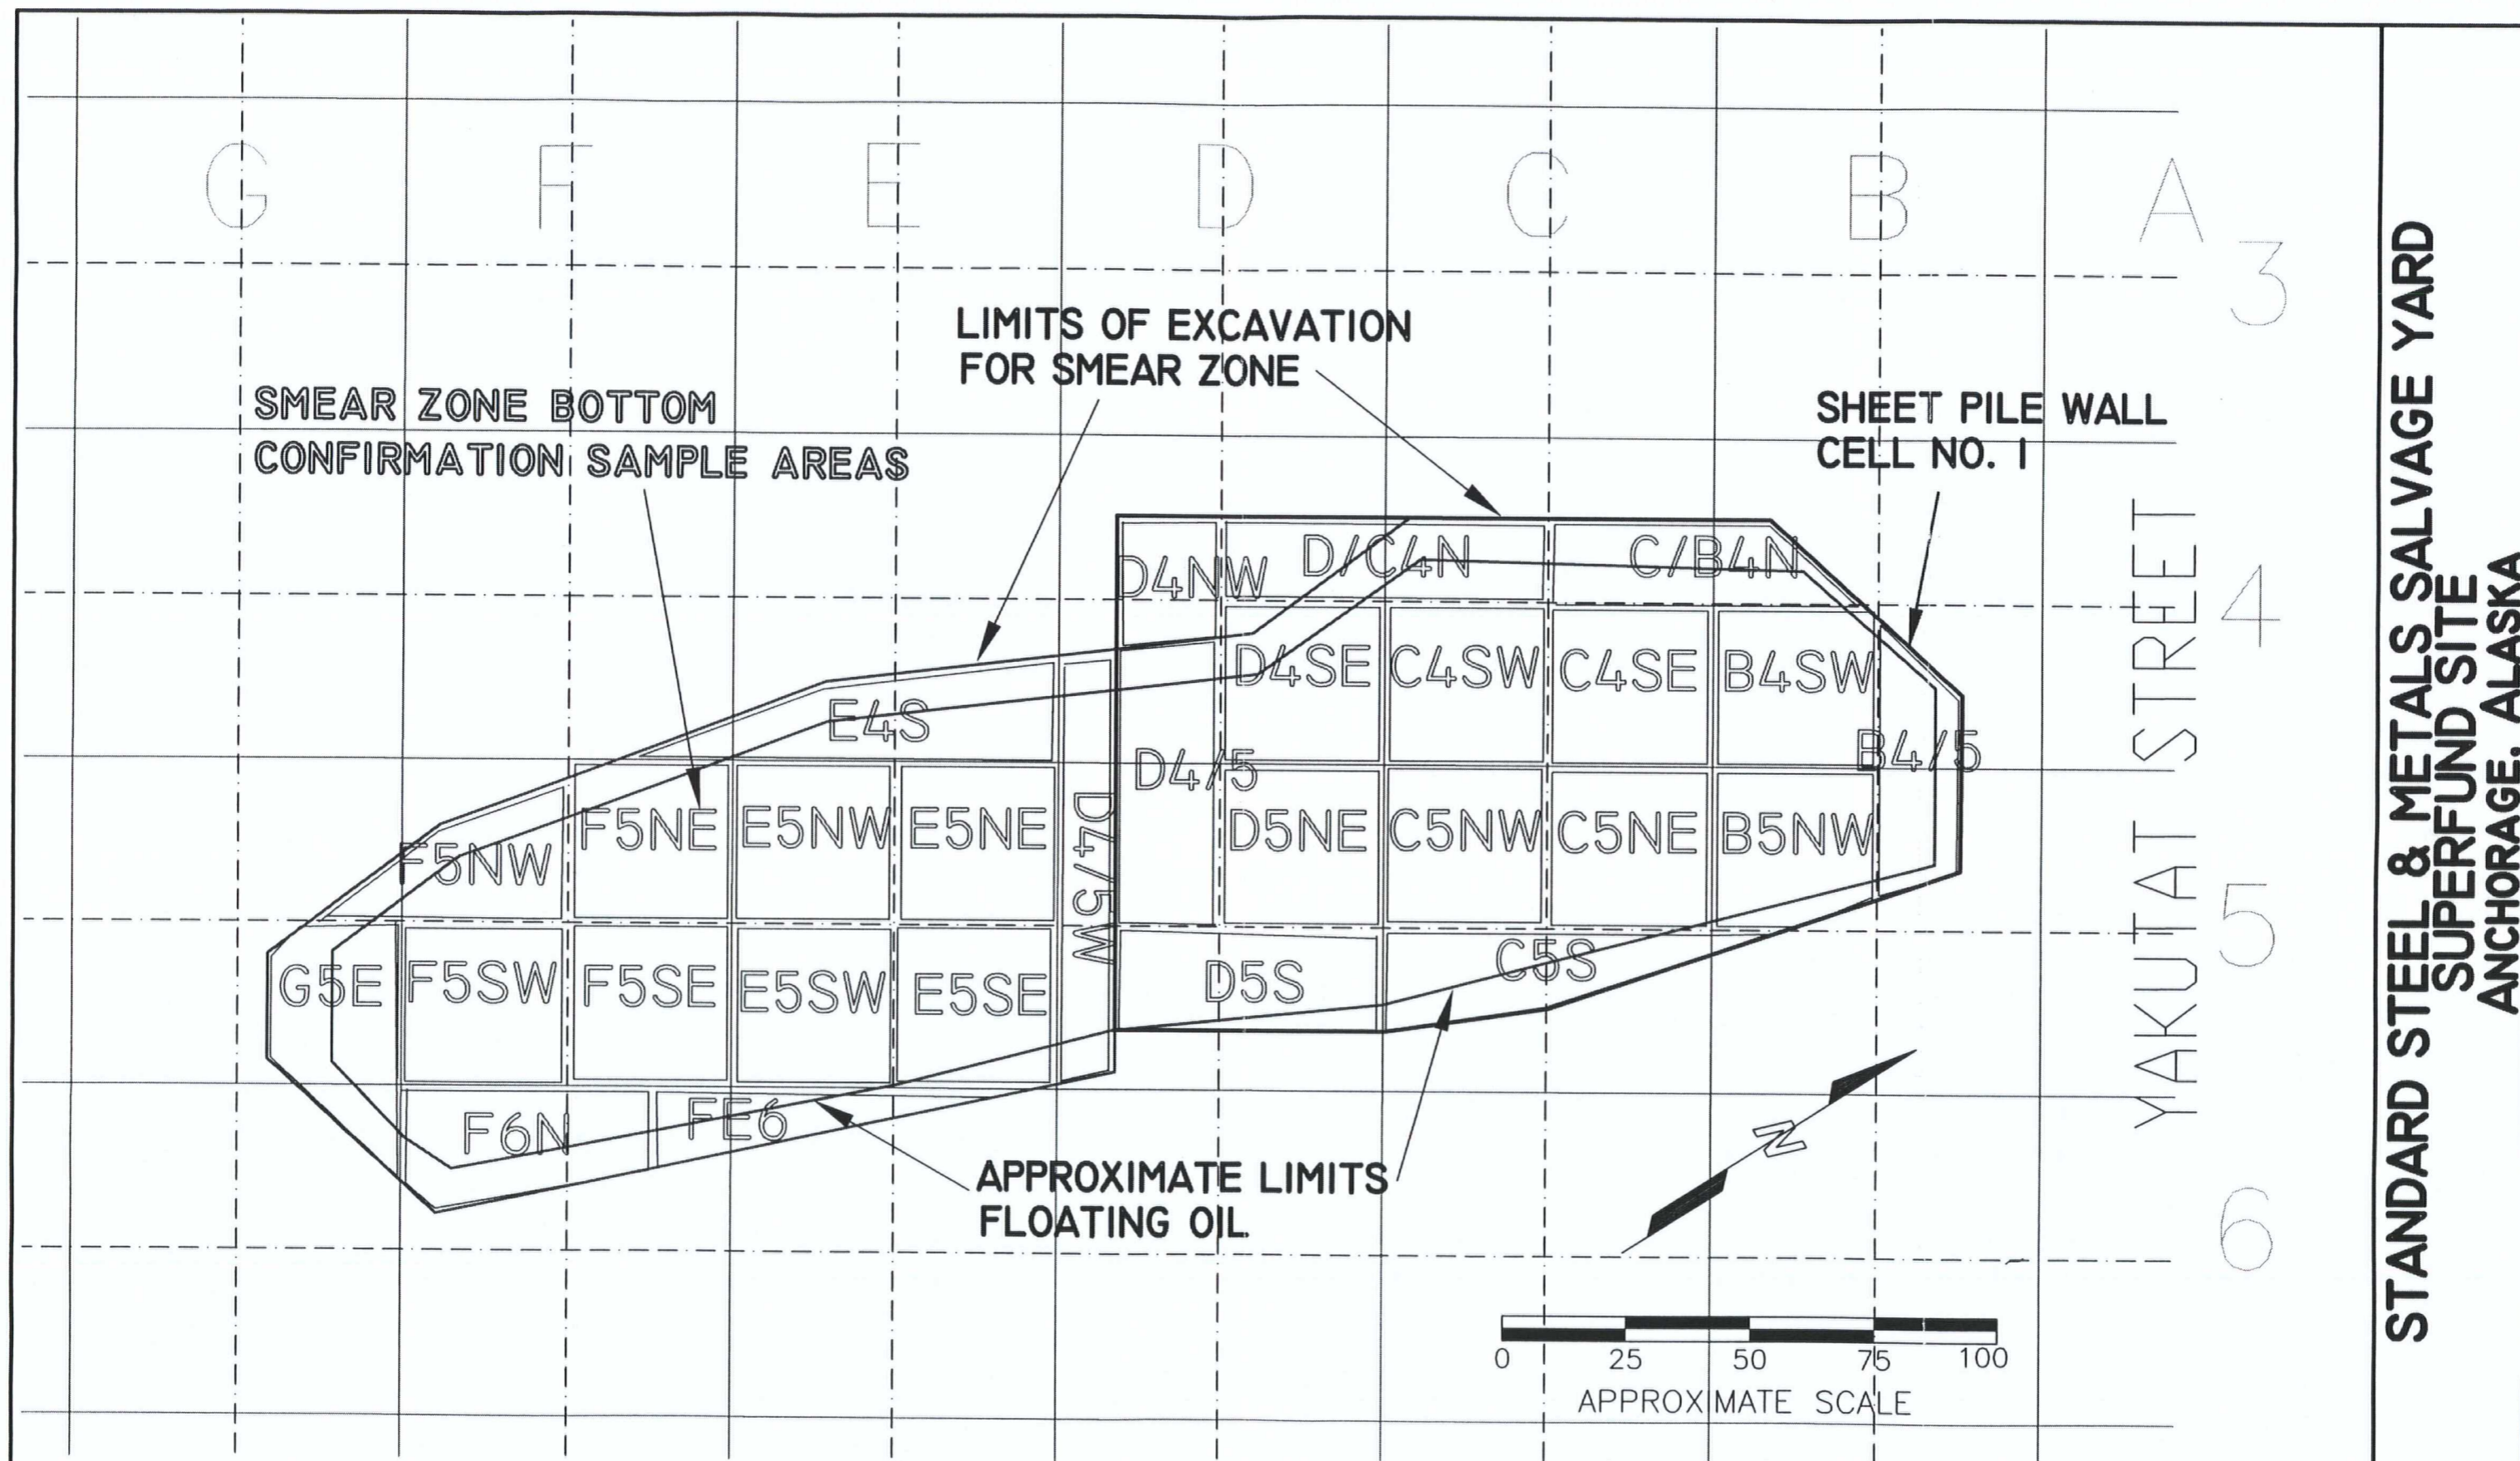
**FIGURE
4-1**

**SMEAR ZONE
CONFIRMATION
BOTTOM SAMPLING**

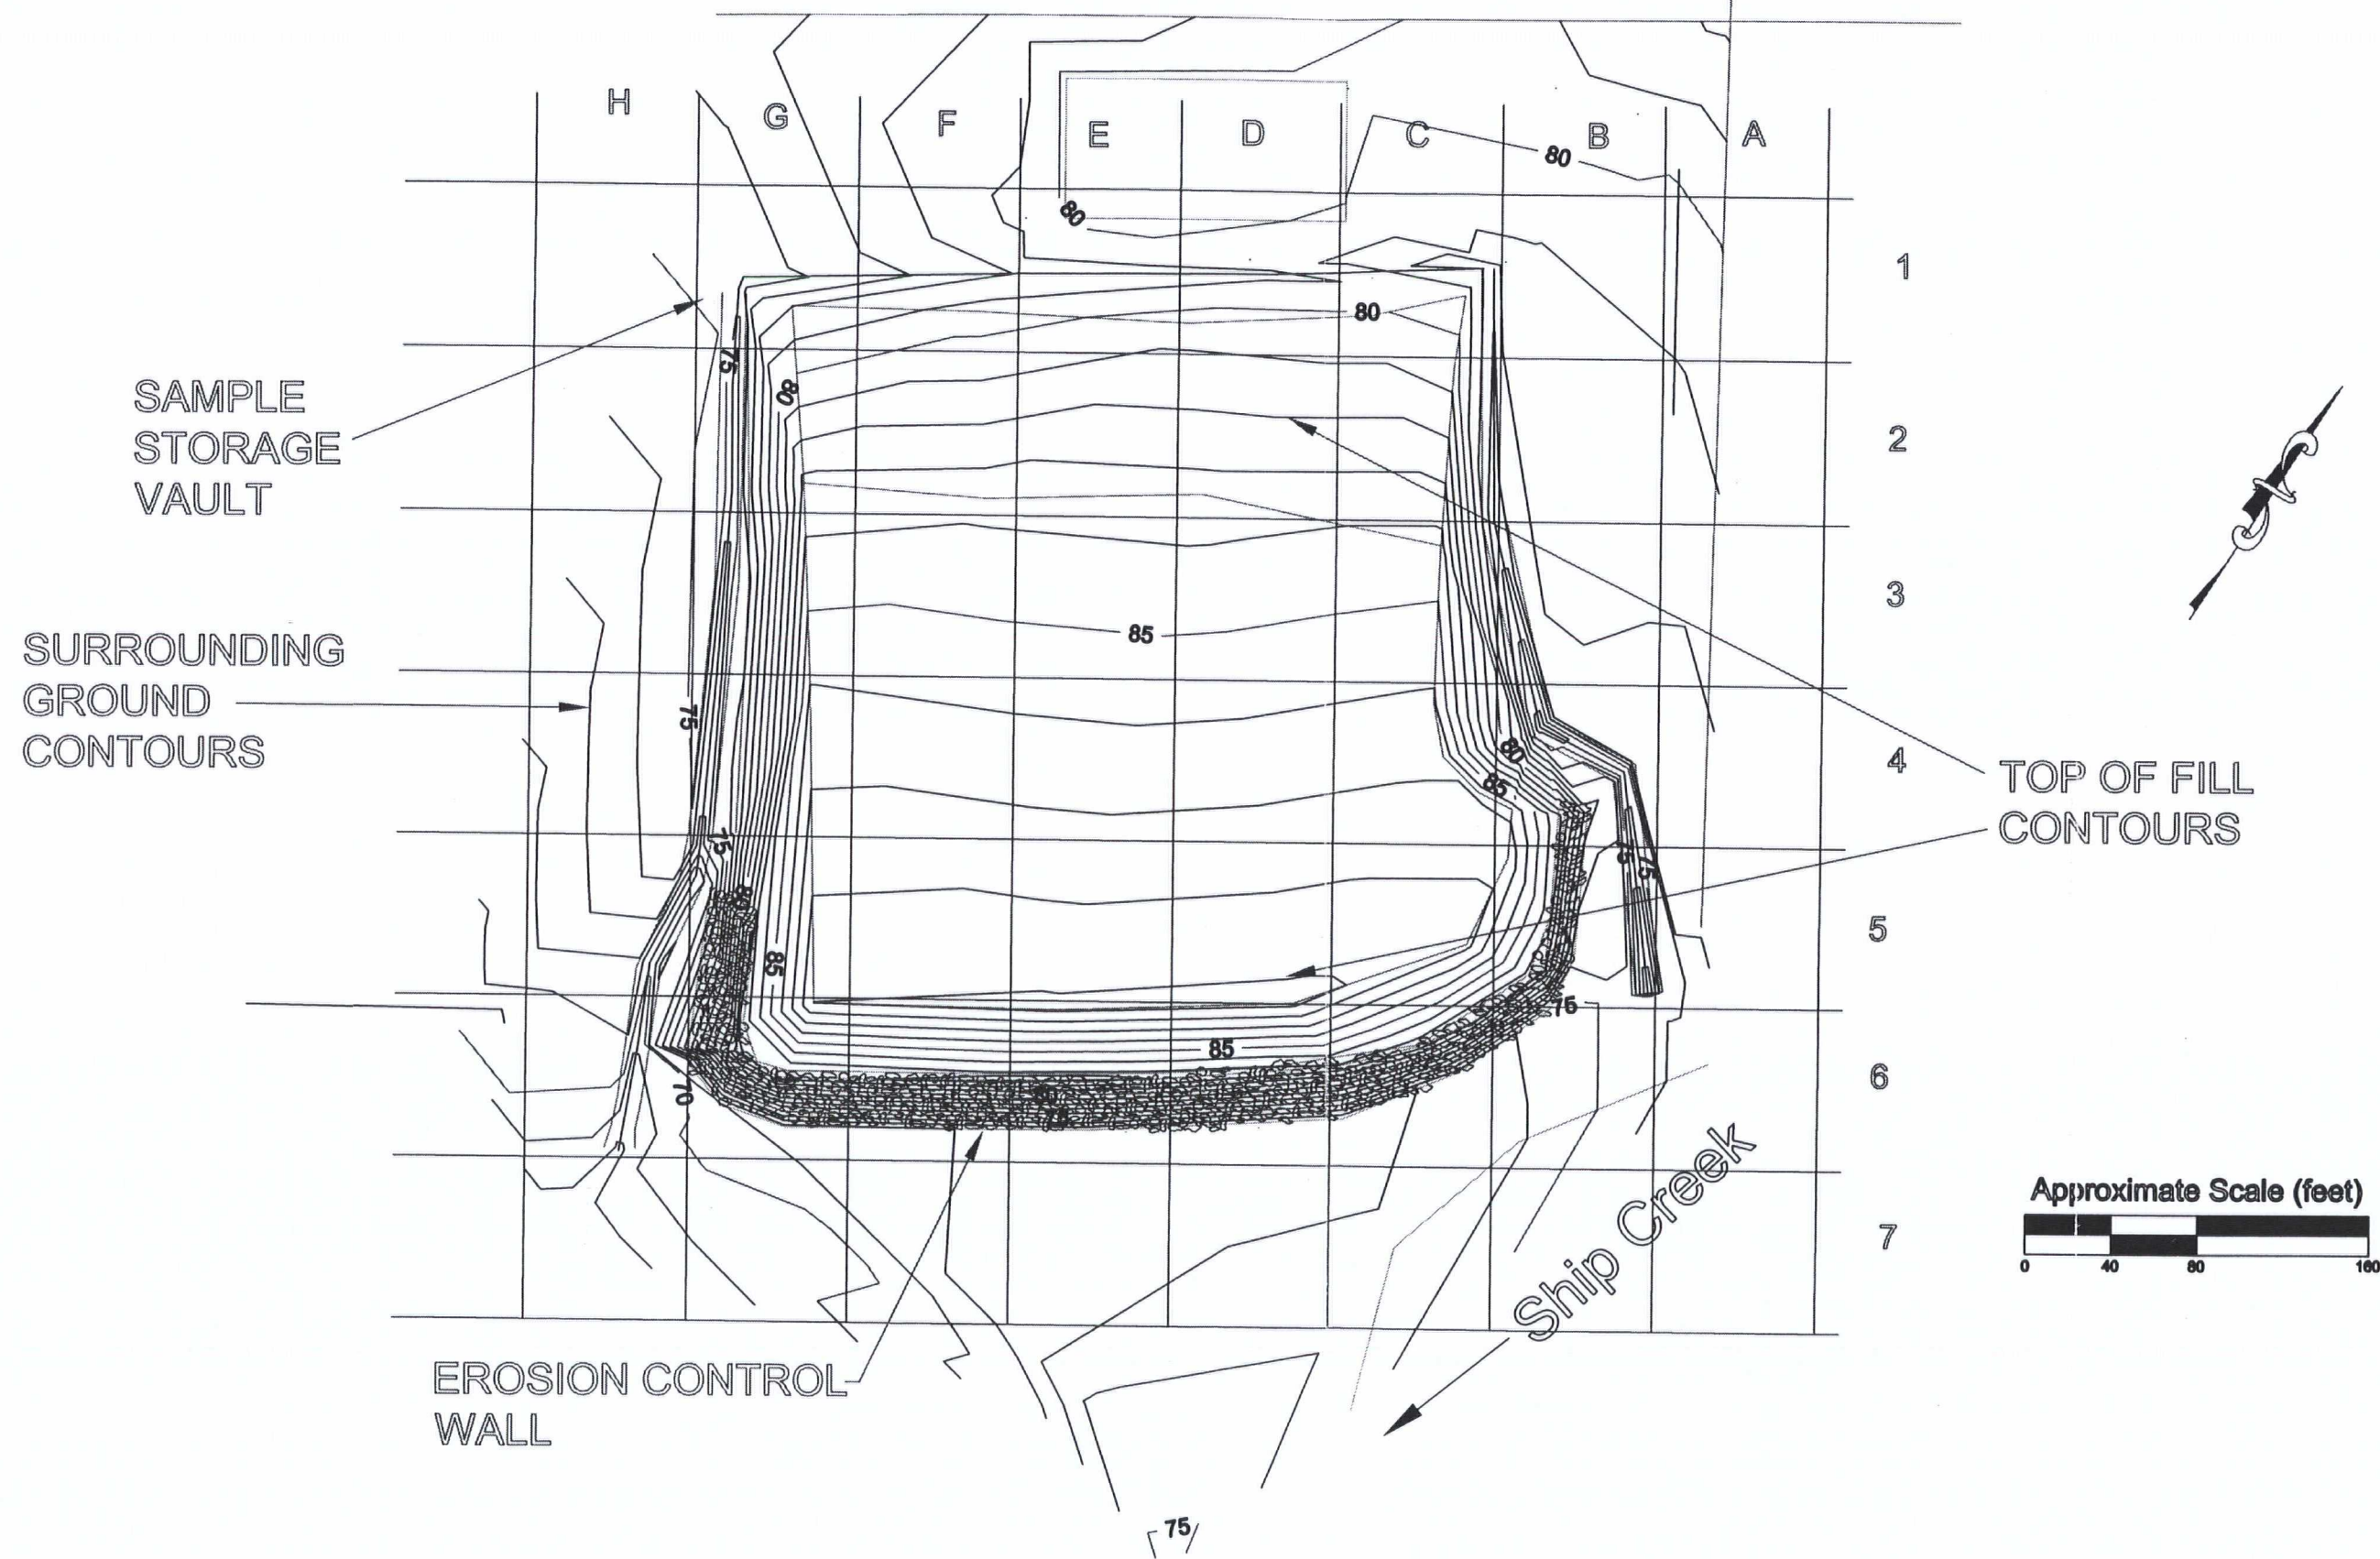
**FIGURE
8-1**

**FINAL CONTOURS
CONSOLIDATION CELL**

The location of the erosion control wall is shown on Figure 8-1. This structure was required to protect the consolidation cell from erosion by Ship Creek, under conditions of (at a minimum) the 500-year flood, as described in the Preliminary Design Report for the project. As shown on the cross-section, Figure 8-6, the erosion control wall consisted of the following components:

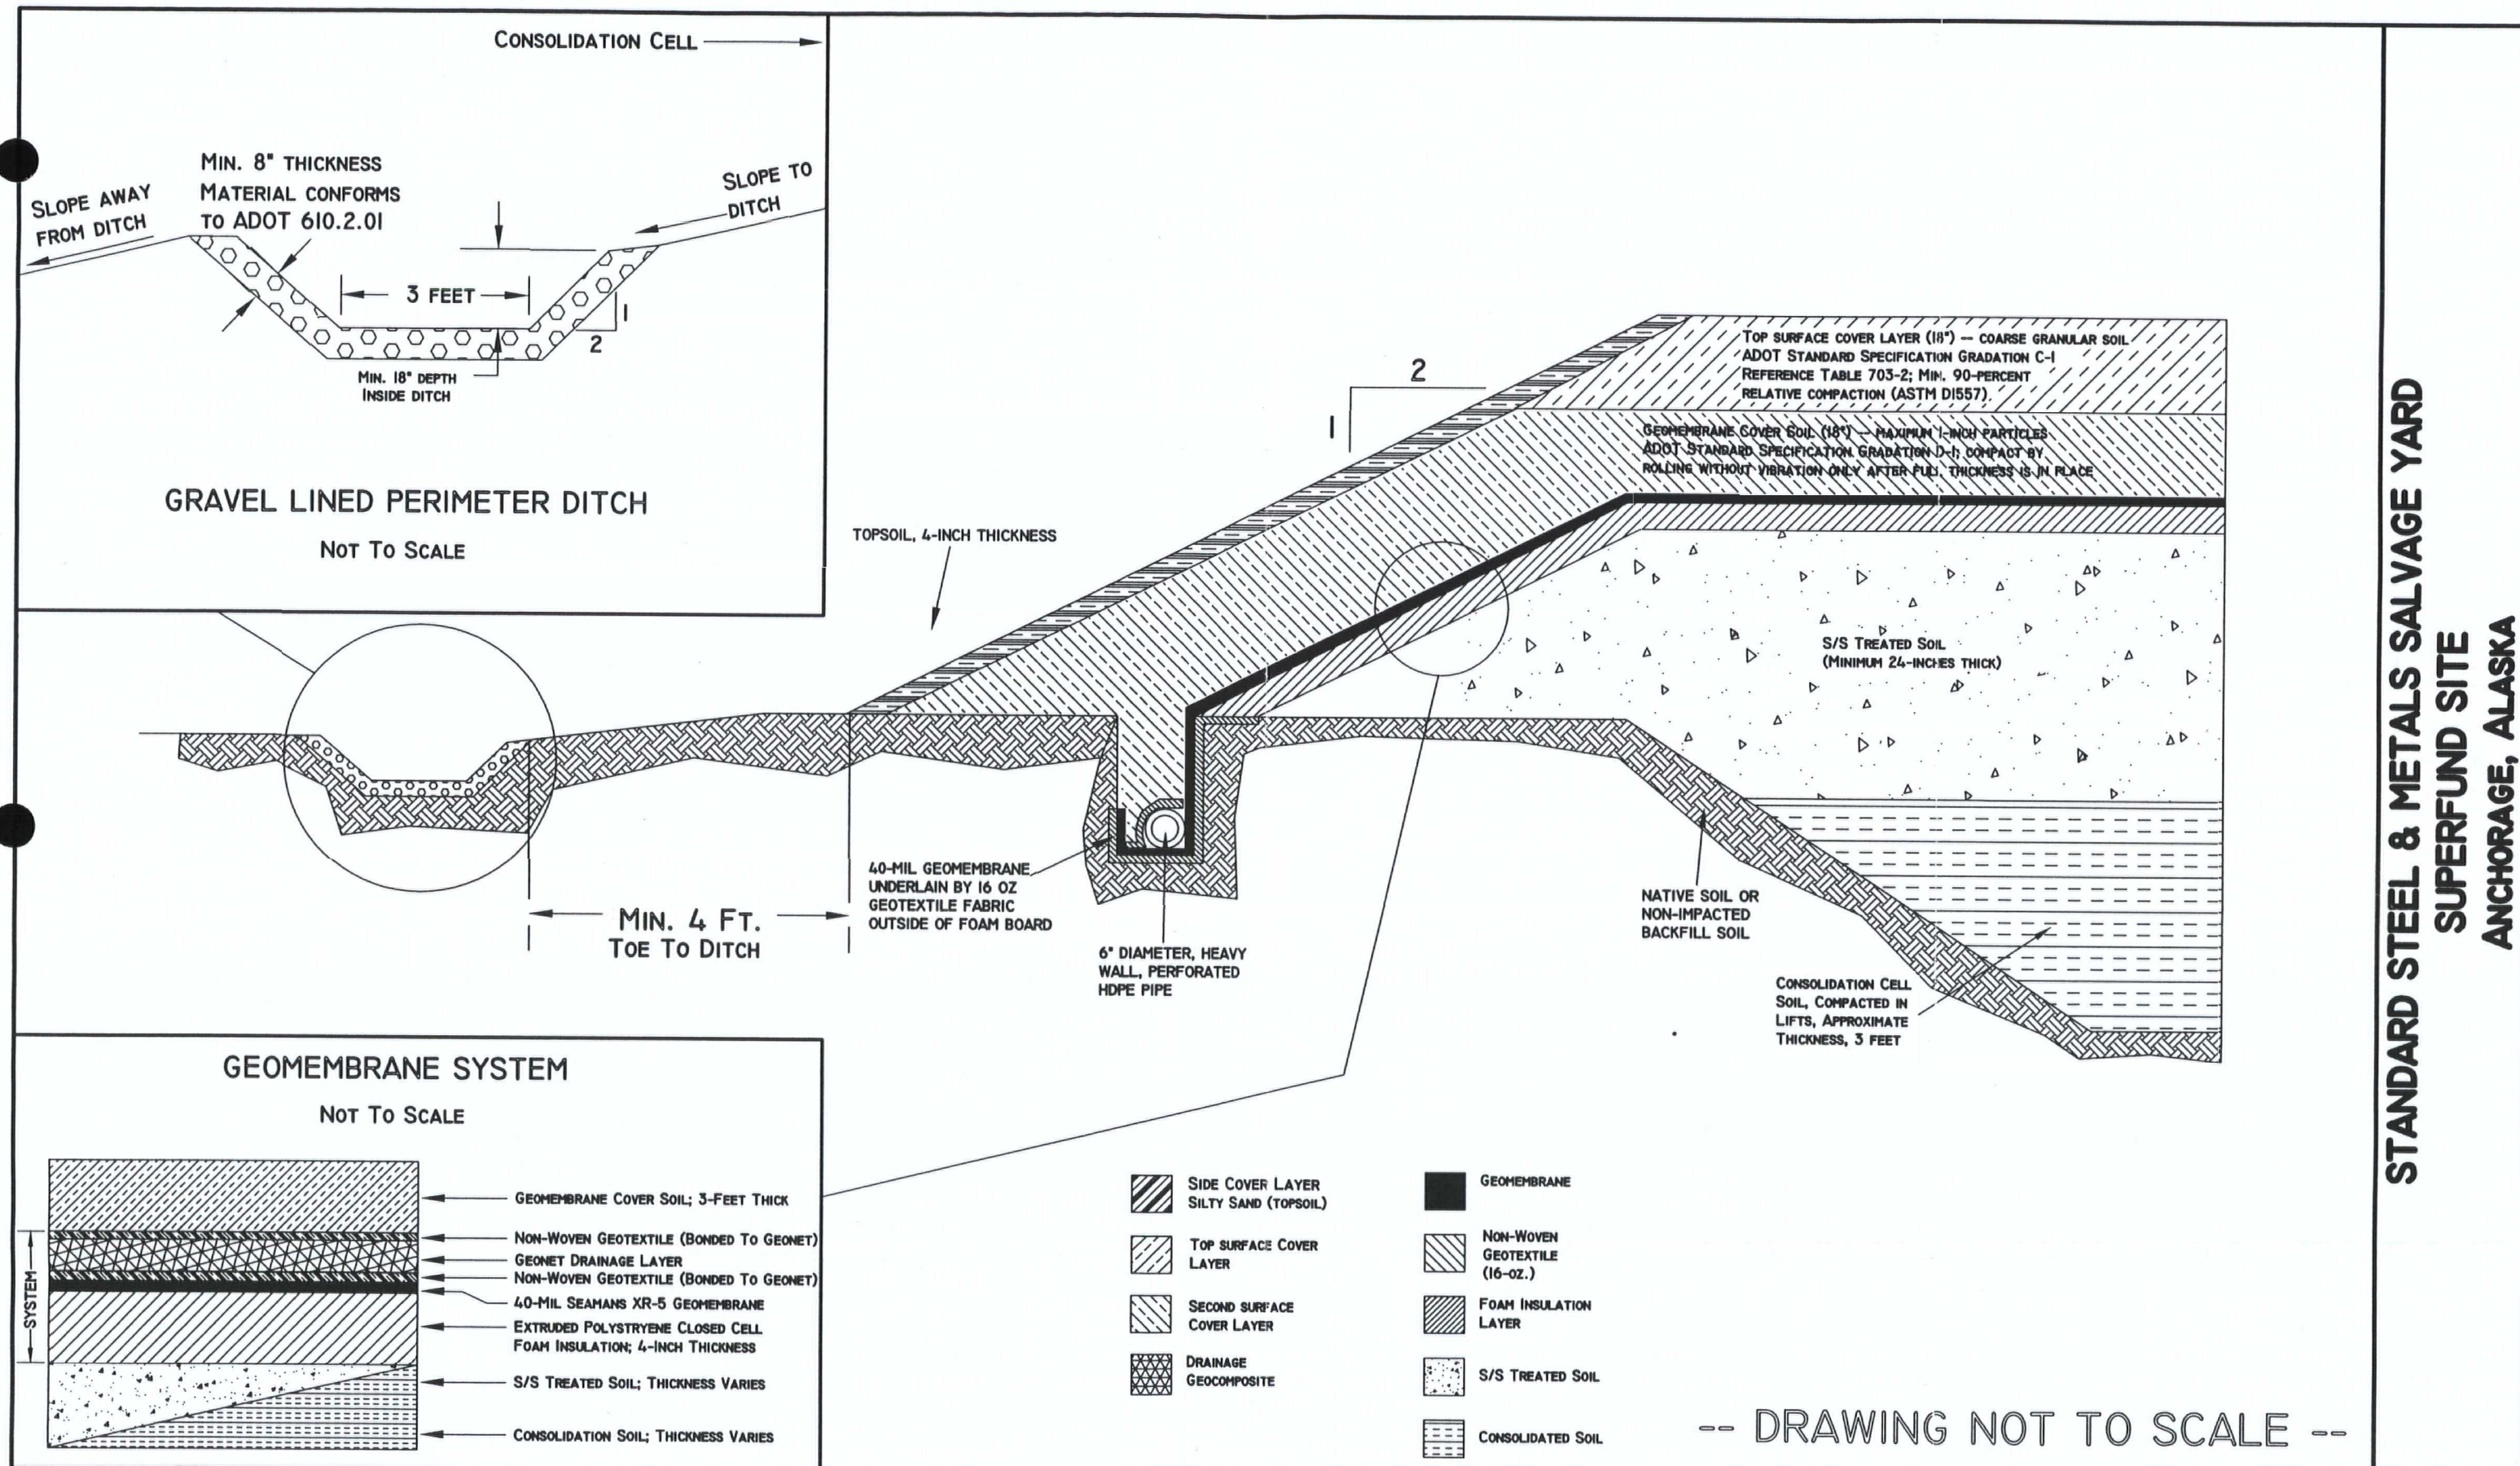
FIGURE
8-2

CONSOLIDATION CELL
EDGE CROSS-SECTIONS
